City of Canton
Stark County, Ohio

SANITARY SEWER OVERFLOW
2009 ANNUAL REPORT

SANITARY SEWER OVERFLOW ANNUAL REPORT

PERIOD COVERED BY REPORT: January 1, 2009 - December 31, 2009

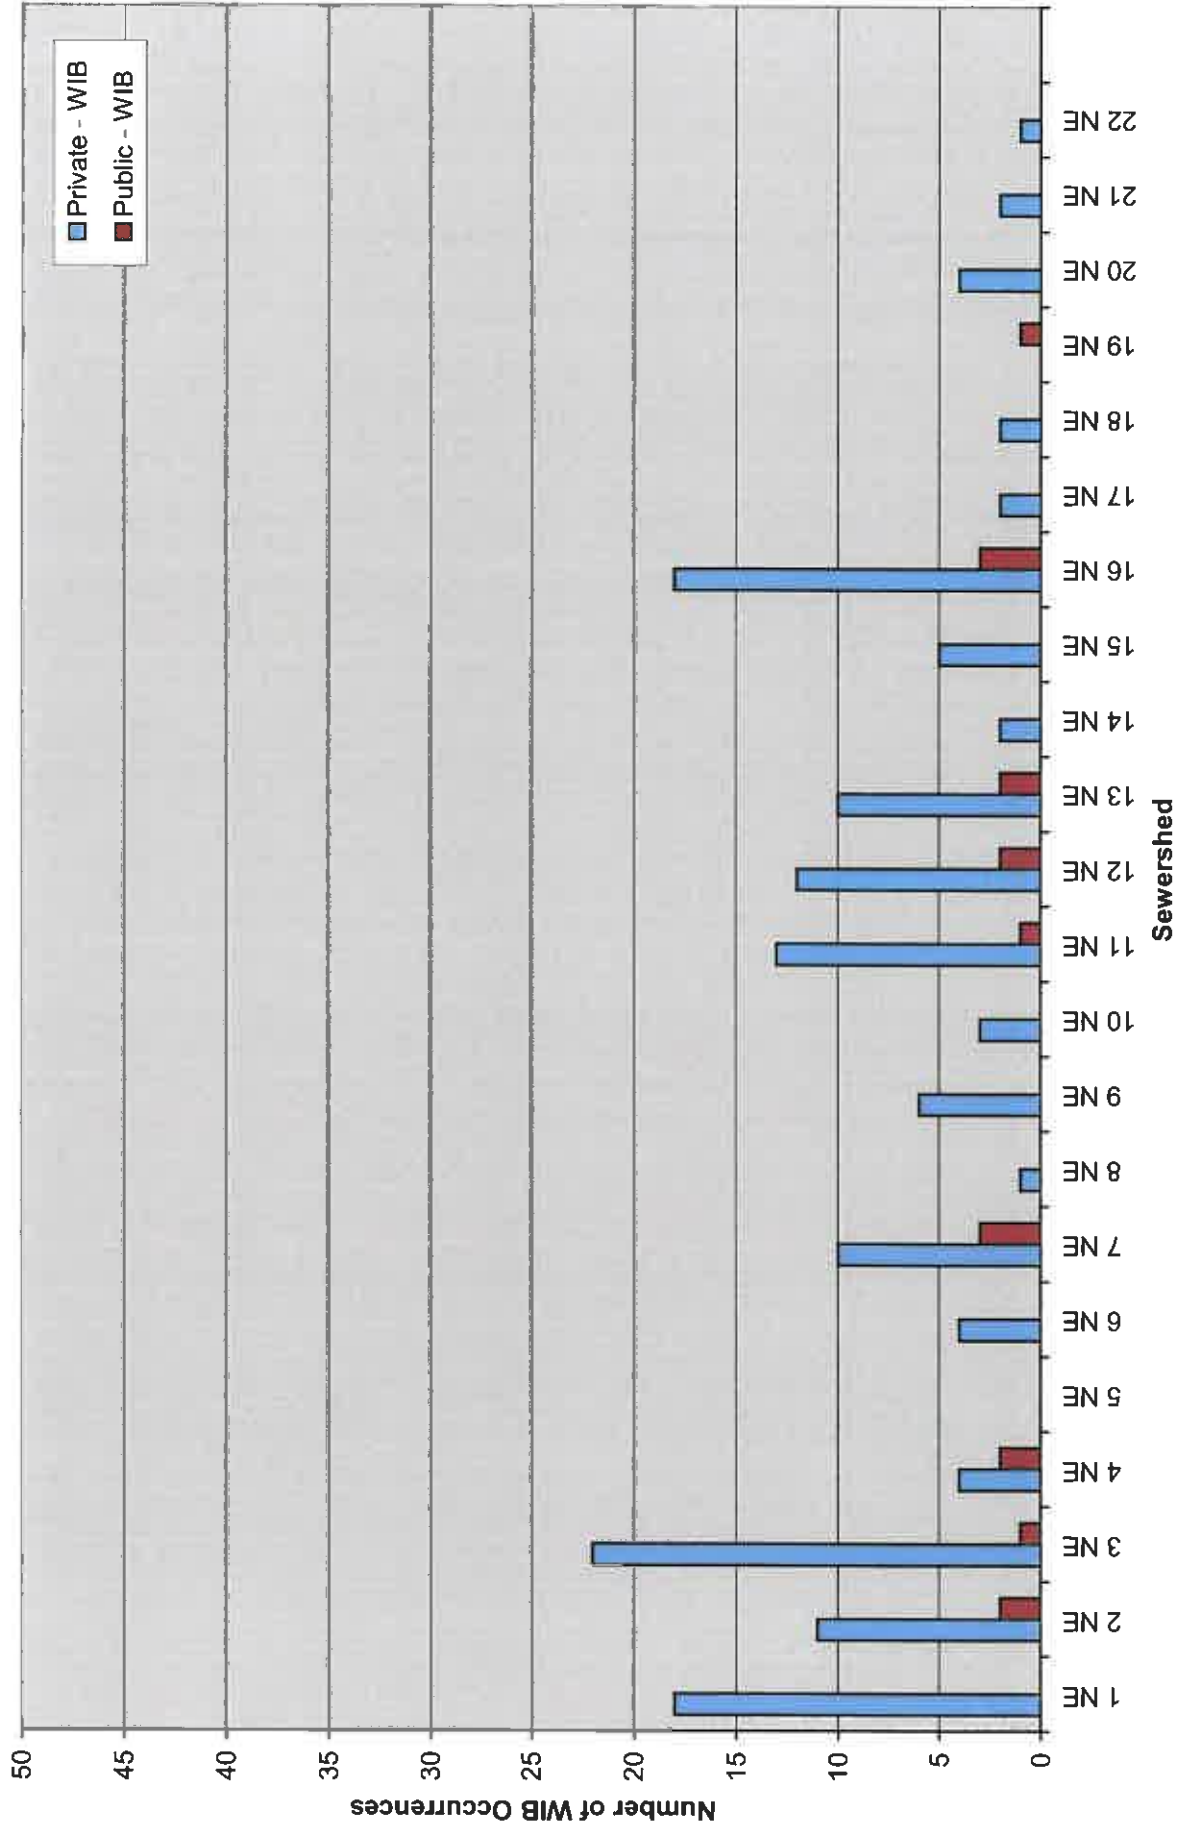
ATTACHMENT B1 WIB OCCURRENCES BY SEWERSHED (NE QUADRANT)

We have also created spreadsheets and charts of each reported WIB based on sewershed. This information is included in Attachments B1 through B4. Based on this information, we are performing this analysis of WIB patterns by location, frequency and cause.

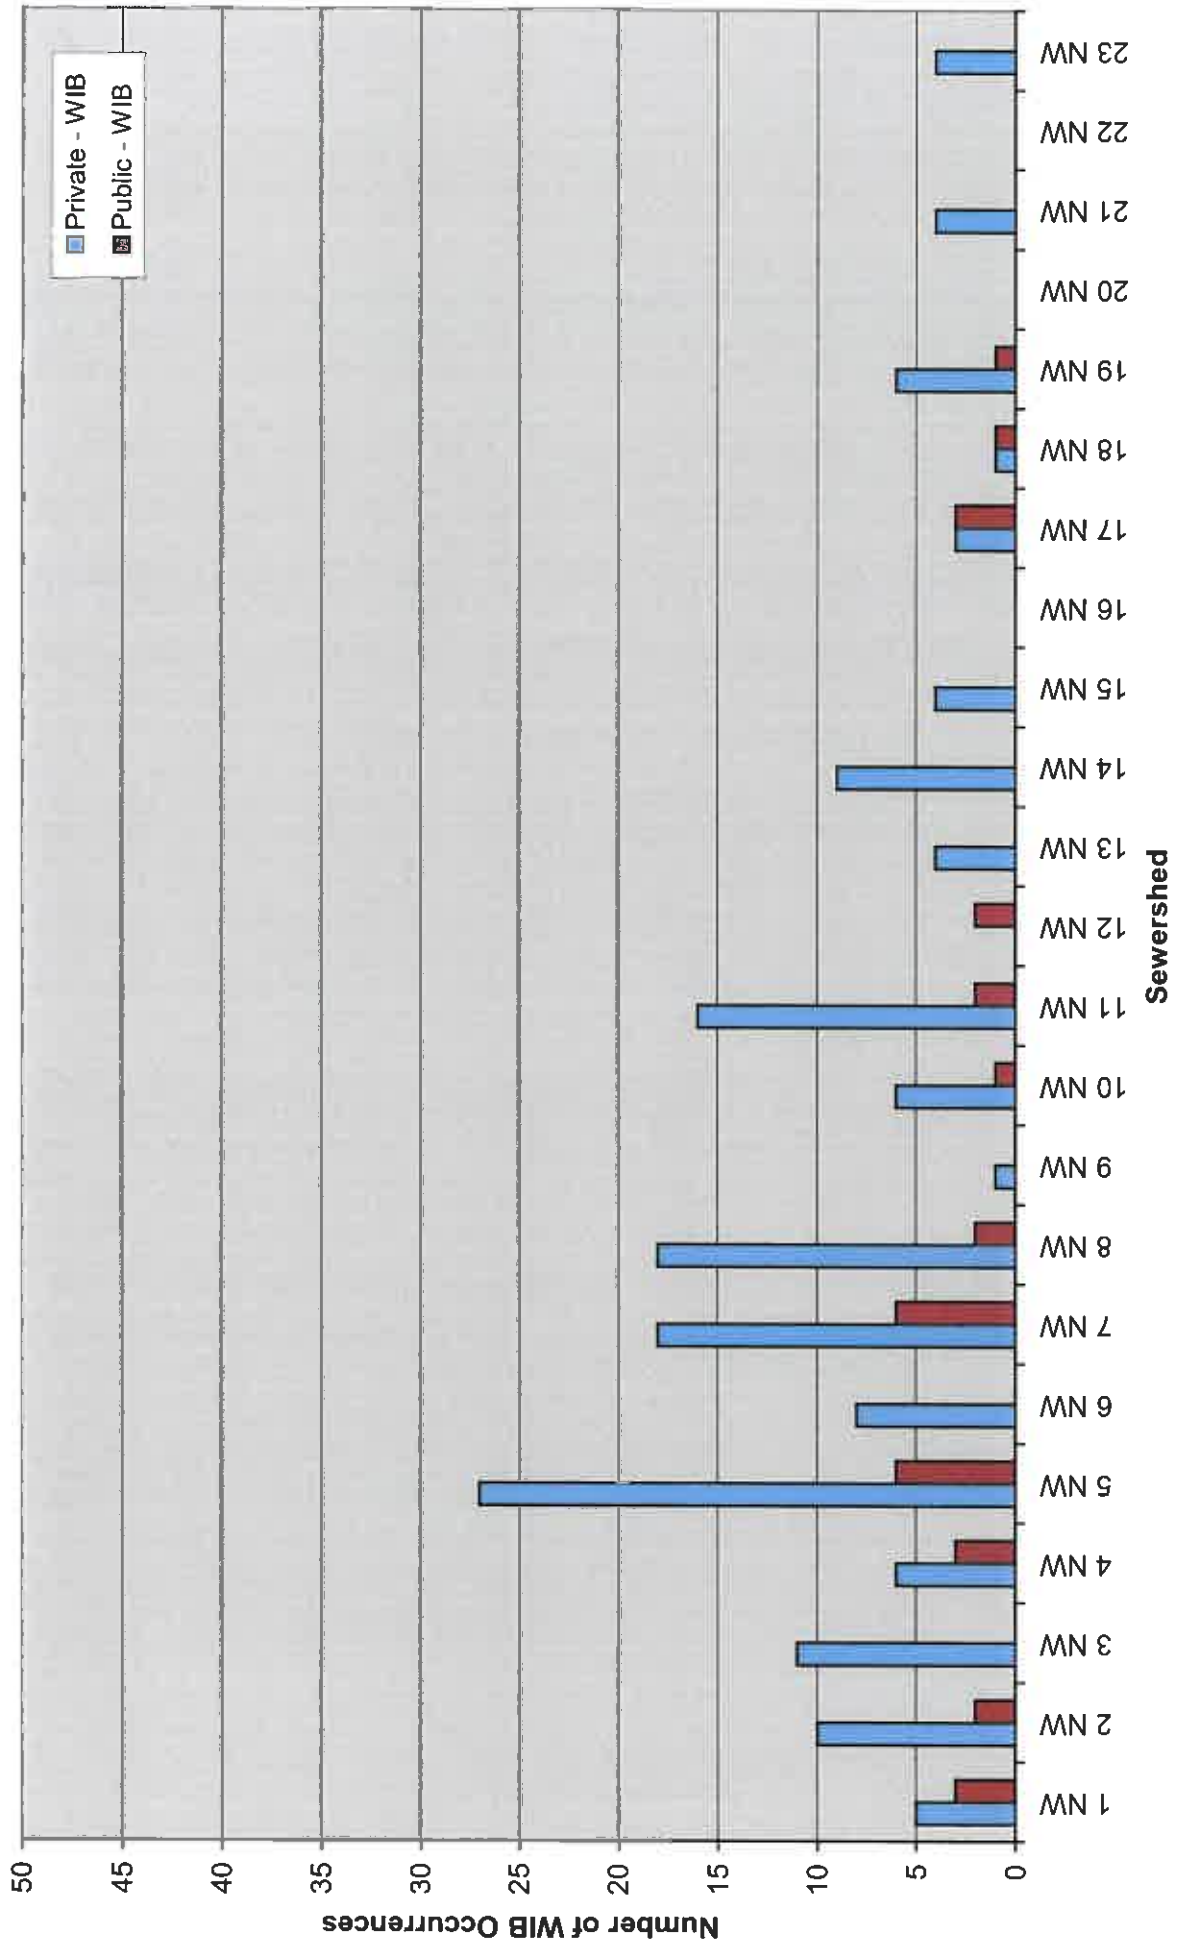
ATTACHMENT B2 WIB OCCURRENCES BY SEWERSHED (NW QUADRANT)

In review of the collected information, we previously investigated sewersheds that had five or more Public WIB occurrences in the reporting year. For this reporting year, there were two sewersheds that meet this requirement (5 NW & 7 NW). Following is further information for each of these areas.

The Public WIB's reported in sewersheds 5NW were all reported on separate dates. Each occurrence was related to a temporary blockage due to grit and/or grease in the main line sewer. This area does not have a history of high water or chronic blockages. However, two reports were within areas with sanitary sewers at minimal grade. This area will continue to be monitored in the future for additional reports of WIB. As warranted, additional remediation will be initiated.

The six reported Public WIB's in sewershed 7NW were also reported on separate dates. Each occurrence was related to a temporary blockage,

typically due to grit and/or grease in the main line sewer. This area does not have a history of high water or chronic blockages. The sewers in the vicinity of the reported WIB's were thoroughly cleaned upon each occurrence and no additional WIB's have been reported. Therefore, we do not believe there is reason for additional maintenance or investigation to prevent additional occurrences.
